SERVICE BULLETIN

Inspection and/or replacement of the valve push-rod assy., rocker arm left and rocker arm right for ROTAX® Engine Type 912 i, 912 and 914 (Series)

ATA System: 72-30-00 Cylinder head

MANDATORY

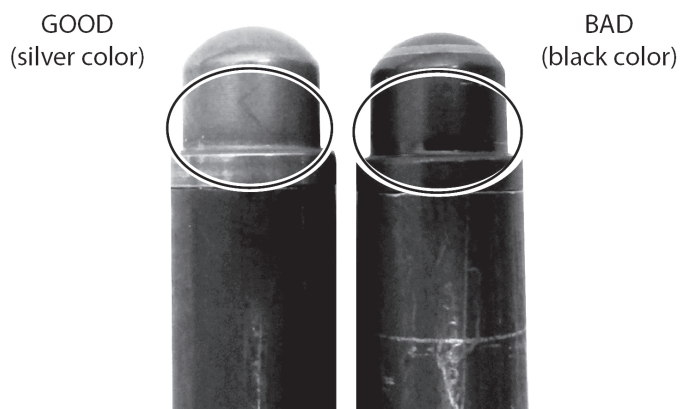
Fig. 1
Visual inspection

Due to deviations in the manufacturing process of the valve push-rod assy., partial wear on the rocker arm ball socket may occur. This wear might lead to a rocker arm cracking / fracture which in consequence may lead to a malfunction of the valve train. Possible effects are rough engine running or an unusual engine operating behaviour.

Perform visual inspection of all push-rod ball sockets on all cylinder.

Check for color. See Fig. 1.

Color	Evaluation
Silver surface	Valve push-rod is OK. No further action required for this valve push-rod.
Black surface	Valve push-rod is NOT OK. See section. 3.1.3) Replacement of affected parts.

On valve trains with valve push-rods found NOT OK the following steps need to be performed:
