SERVICE INSTRUCTION

Introduction of a new clamp part no. 638140 for ROTAX 912 i Series

ATA System: 76-00-00 Engine control

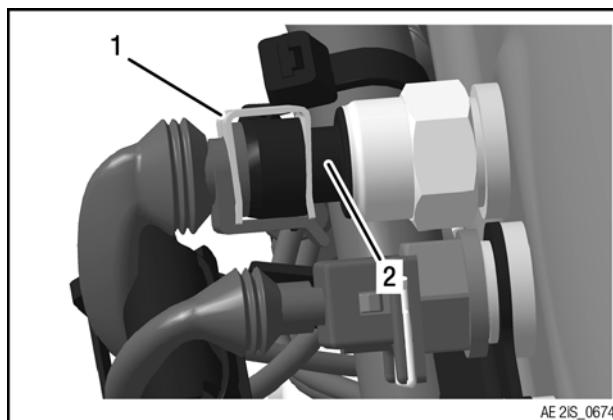
Fig. 1

In the course of continuous development an additional clamp part no. 638140 has been introduced, which improves the connection and tight fit of the MAP sensors.

- 1) Clamp
- 2) MAP Sensor

POSITION OF THE CLAMP

Step	Procedure
1	Check connector of MAP sensors for tight fit. NOTE: Make sure the connector latch shows vertically to the bottom.
2	Install the clamp as shown in figure 1. Check for tight fit and correct position of the clamp on sensor and connector. NOTE: To remove the clamp use a proper pair of pliers.

- Restore aircraft to original operating configuration.
- See latest Maintenance Manual (Line), maintenance checklist. The clamp itself needs to be visually checked and also checked for tight fit at least every 100 h of operation and/or at next maintenance event.
