# SPA-400 / 600 EXTERNAL MIC INTERRUPT MODIFICATION

**SCOPE:** This modification applies to a Sigtronics SPA-400/600 or ST-400/600 installations.

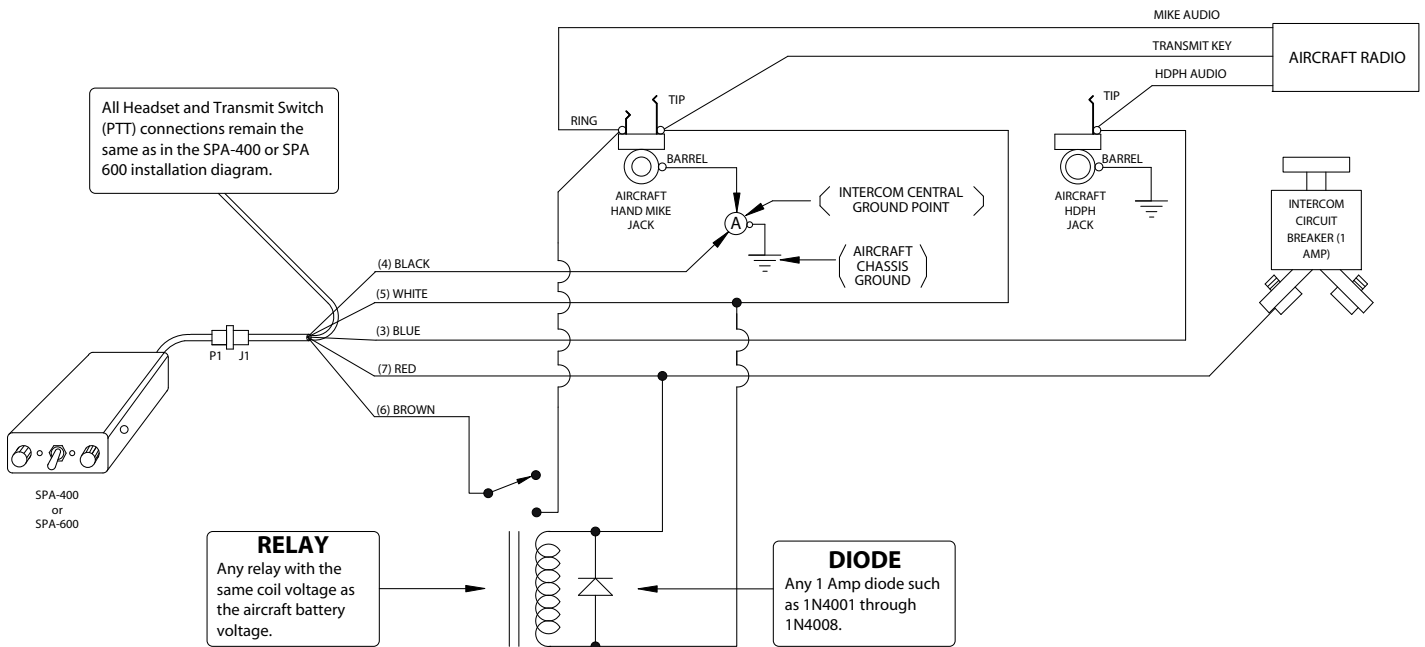
**PROBLEM:** The intercom stays hot or stays live all the time no matter what position the intercom squelch is set to. Most common with Terra radio equipment, King KY-92 radios, and a few others.

**VERIFICATION:** Turn off or disconnect the aircraft radio(s) from the intercom. If the intercom squelch now works - the radio(s) are bypassing the intercom and providing a "HOT MIC" type intercom.

1. Pull out the SPA-400/600 unit and send into Sigtronics for an internal modification. Request a "MIC INTERRUPT MODIFICATION". There is a modest fee for this.
2. If time does not allow this, a small relay can be added to the installation that will accomplish the same thing. Follow the wiring schematic below.
