# MANDATORY SERVICE BULLETIN

Middle Fork Mods

Reference: MFSBM-2501 Rev 00

Mandatory Service Bulletin - Kit for STC SA011869WI

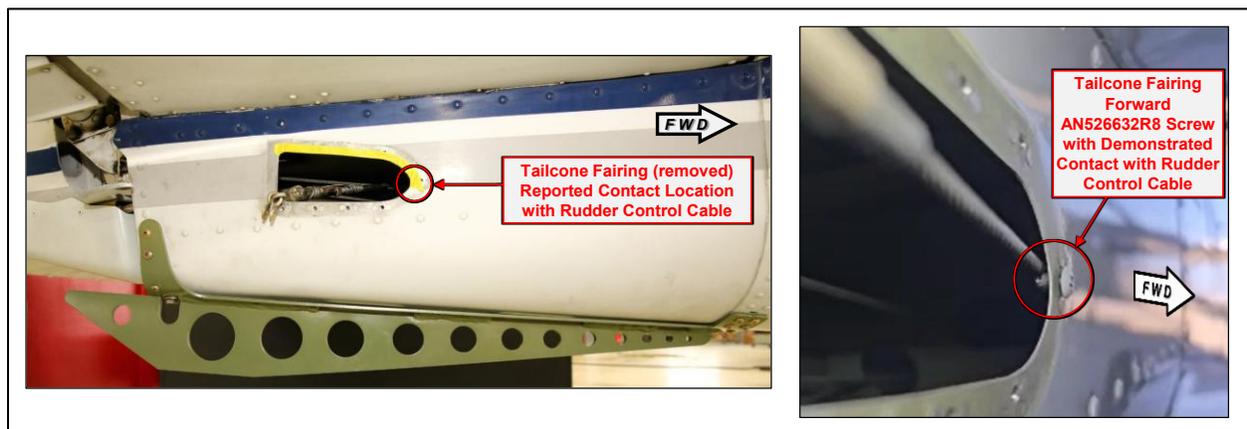
Figure 1: Affected Area

There is a potential safety issue regarding the installation of the Tail Tie-Down Assembly interference with the rudder control cable. Two incidents have been reported in which the installation of this modification results in the rudder control cable contacting a fairing screw installed by this Kit. This condition could result in severance or fraying of the cables with loss of rudder control. Figure 1 identifies the area in question.
