# Part #50 – Curing Rotary Valve Shaft Problems

By Mike Stratman

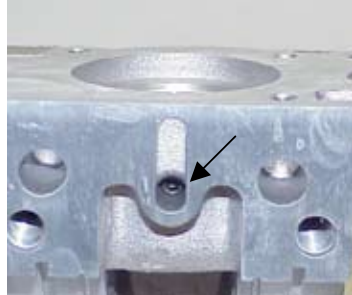
**Production Variations:** In an effort to solve the shorten life span on these parts the factory made a number of changes. First, way back in the 532 series engines, the shaft diameter was reduced from 12mm to 10mm to reduce the speed on the shaft and seal. This required the shaft and the seal to be changed. 10 years and factory replacement parts makes running into this 12mm set-up extremely rare. The major changes can when the weep hole or witness passage was plugged off. A passage cast into the crank allows for the vented of the gap between the two facing seals directly behind the water pump impeller. Once either of the seals failed a fluid drip would signify which seal had failed. Unfortunately some operators would mistake this for a water pump housing gasket or crankcase leak and start torquing the water pump bolts or replacing the gasket. This of course did nothing to stop the leak and often times resulted in stripped threads in the crankcase. The photo in Figure #1 shows the passage with a setscrew plug. You can do this yourself with the right size set screw and a little tap and thread savvy. See figure #1

Figure #1 – A setscrew plugs the cast passage in the upper case half that leads to the area between the two shaft seals. See arrow for setscrew.

The setscrew plug also made it necessary for both seals to fail before there could be an exchange of fluids. But the cavity **must be** filled with a lithium or silicone grease to prevent thermal expansion. I have personally seen the seals be forced out the hole in the freeze plug the first time the newly assembly area came to operating temperature. More about this when we talk about re-assembling the parts.

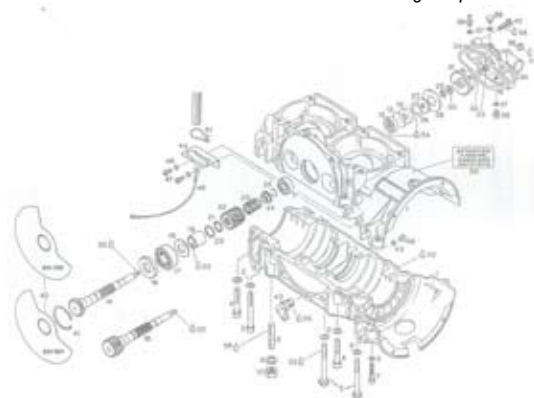
Figure #2 – Shows the order in which the parts located in the 532-582-618 engines. Be sure #16 snap ring is removed before pushing the shaft out from the opposite side of the engine.

**Removing the RV Shaft:** Surprisingly enough repairing this area can be accomplished in most cases with the engine in the aircraft. You need to remove the water pump housing and impeller as well as the RV cover behind the carburetors. Remove the snap ring #41 in Figure #2. You may also find a metal "freeze plug" #28 guarding the shaft seals. This will have to be destroyed for removal. At this point you can, only with the right tool, hammer the shaft out from the water pump side. See figure #3. Don't ever think about using a hammer on the naked end of the shaft. Part #876-612 is an inexpensive (for Rotax) tool that threads onto the end of the shaft and allows you to hammer the shaft out. The spring #23 may compress in the process.

**Conclusions:** We posed the question in the beginning "What do I do if water is in the RV Fluid, Can I still fly it?" The answer is a cautious yes. If you are near the 150 or 300 hour inspections, go ahead and change the fluid by pulling the drain plug (#49 in figure #2) and nurse it to your next service interval where you will use the knowledge gained here to service this area properly. Check the fluid often to see the severity of the leakage. Remember that the coolant is under pressure while the RV is just a bath so the RV fluid should be contaminated first. Only in severe cases will the coolant be contaminated as well. If completely neglected the fluids will coagulate or "milk" which will eventually pit the bearings.

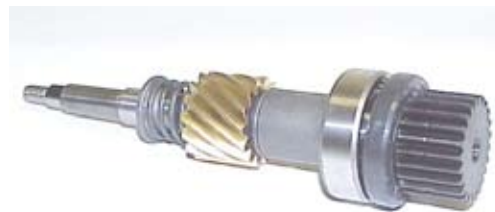
Figure #4 – With the shaft removed inspect the area where the two #17 seals have been operating. Replace if worn or grooved.

Once the shaft is removed you will find a number of parts assembled shish-a-bob style on the shaft. See Figure #4. Compress the spring and remove all parts for inspection. What you need to look for carefully is any cutting or grooving of the shaft in the area where the #12 seals have been running. Replace shaft if wear is present. Removing the #12 seals means destroying them with a seal hook. Take care not to damage the seal passage.

**Reassembling the Shaft:** It is advisable to replace all the seals and to inspect the brass gear thoroughly for wear. You can buy the RV Shaft with all the parts already assembled as shown in Fig. #4 Ask for Part #1351. It comes assembled for the price of the parts only. Install the first #12 seal into passage with the flat side facing out. Rotax makes some very nice and very expensive pushers for installing these seals but generally just the right size deep socket will work fine. Apply lithium or silicone grease liberally to the face of the first seal. This is needed to prevent thermal expansion if an air pocket was left between the seals. Install the second seal with the flat side in. Install the shaft back from the intake side making sure the gears mesh without force. Another inexpensive tool from Rotax # 876-980 can be threaded onto the shaft that protects the seals as the shaft is inserted. See Figure #5. Wipe excess grease from area.

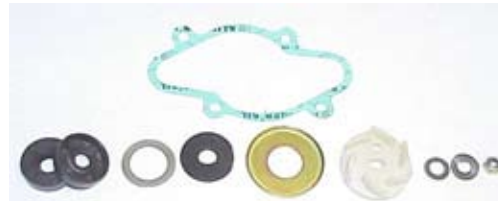
Figure #6 – Several parts after seal pair are now considered optional. The freeze plug and associated parts help prevent seal walk.

There is a progression of parts that are optional after the seals are installed. A shim, rubber disc, and metal freeze plug can be tapped into cavity for extra support to prevent seal walk. See Figure #6 for parts progression. Reinstall water pump impeller and housing.

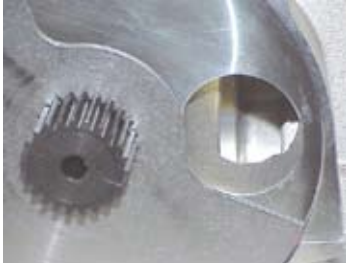
Figure #7 - With the Mag side piston at TDC install the valve plate as shown with the plate right at or just above the bottom of the Mag side port. Flipping the plate over will give a slightly different positioning.

**Timing the Rotary Valve Plate:** With the Mag side piston at TDC install the valve plate as shown in Figure #7 with the plate right at or just above the bottom of the Mag side port. Flipping the plate over will give a slightly different positioning.

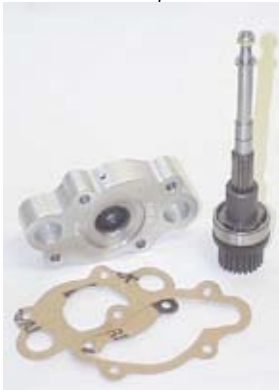
Figure #9 – This aftermarket kit uses a longer shaft plus an extension block to add an extra pair of seals. To change these seals all you have to do is remove the block.

**Aftermarket Solutions:** Failures of the RV area are common enough for an aftermarket solution to appear. The designer here has come up with an elaborate set up that includes a completely different longer shaft that allows the regular block seals to remain in place and adds an extra pair of seals in a special extension housing. In order for this system to leak you need to loose no less than four seals before a fluid exchange takes place. The other advantage is that to change the outer seals all you need to do is remove the block. The shaft stays put unless it has been grooved. Not a bad fix but with all the new parts you need the conversion is on the expensive side. See Figure #9 for most of the new parts needed for this conversion.

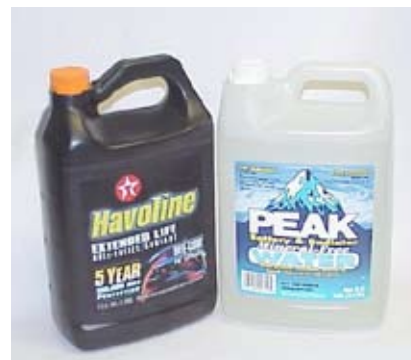
Figure #10 – Havoline Dex-Cool is a patented formula that is silica free. Mix only with mineral free or distilled water to reduce contaminants.

**The Trouble with Silica:** What's silica? Most antifreeze formulas include a small amount of a substance known as "Silica" or SiO<sub>2</sub>. Webster's Dictionary states "Silica is a white or colorless crystalline compound. Occurring as a quartz, sand, flint, agate, and many other minerals and used to make glass or concrete." In short silica is an abrasive compound. Silica will come out of solution during temperature spikes in the cooling system. Silica will then collect on the RV shaft at the seals and acts as an abrasive to allow the contact to cut the shaft. Ever look at the bottom of your radiator cap and see a gel like substance, this is silica. Or if you pour the fluid out and you find a flake like film, that is also silica. In order to get a silica free coolant you need to look for Havoline Dex-Cool® or extended life coolant. This formula is usually an orange color and needs to be mixed 50/50 with mineral free or distilled water as shown in Figure #10. Some Dex-Cool formulas may be already mix 50/50, so check the label carefully. Wouldn't you know it, the black gallon container shown here makes no mention of the word "silica". According to what I understand Dex-Cool® is a patented formula and a closely guard brand name. These products can be found at most automotive parts stores.

**Test have shown that once silica and other contaminants are removed from the coolant the shaft seal cutting problems literally cease to be a factor.** Snowmobiles using the same engines have had little trouble with RV seal because the original equipment comes from the factory with the right coolant. Obviously this is not the case for our industry as most aircraft are supplied in kit form allowing the operator to use most anything for coolant.

For a lot of reasons the fix for this persistent problem was not as obvious as it should have been from the beginning. Silica free coolants are a fairly new product and are fast replacing the more inexpensive products that contain a certain amount of silica. According to factory technicians use of Dex-Cool or any other silica free coolant will allow the RV shaft and seals to last up to and past the recommended 300 hour TBO. A bit on the expensive side, I found it for \$8.00 at the local PEP Boys Store. A gallon of mineral free water was a \$1.50. If you are using tap water or plain antifreeze you might think about investing a few bucks in a coolant change. The savings could be considerable.
